Attachment A. Maps and Photos
Repair of Created Stormwater Treatment Wetland
RFQ 19-035

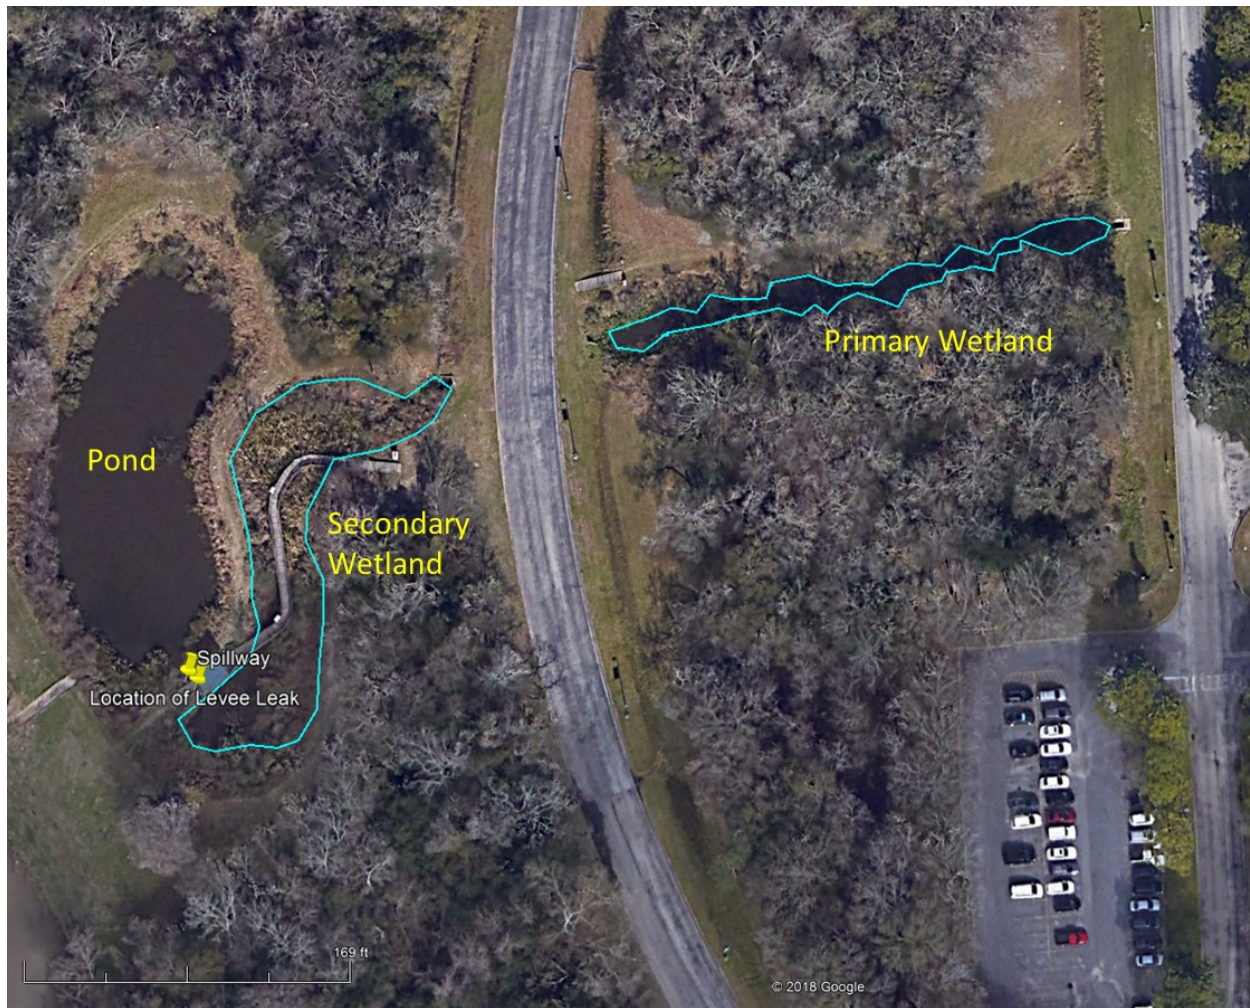
Figure 2. Location of primary and secondary wetland and levee leak.

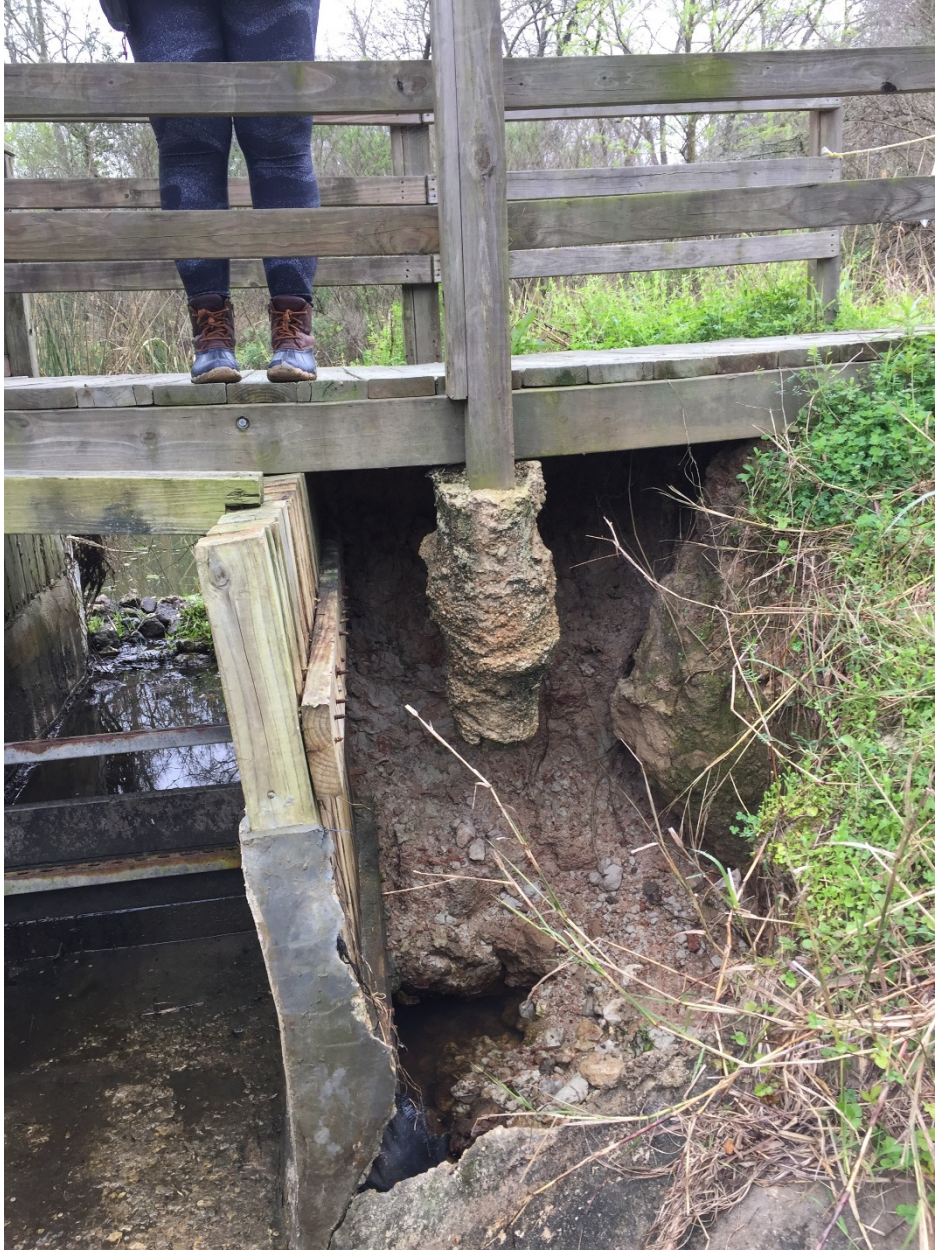
Figure 5. Erosion of levee around the spillway weir. Facing upstream from pond into primary wetland complex.

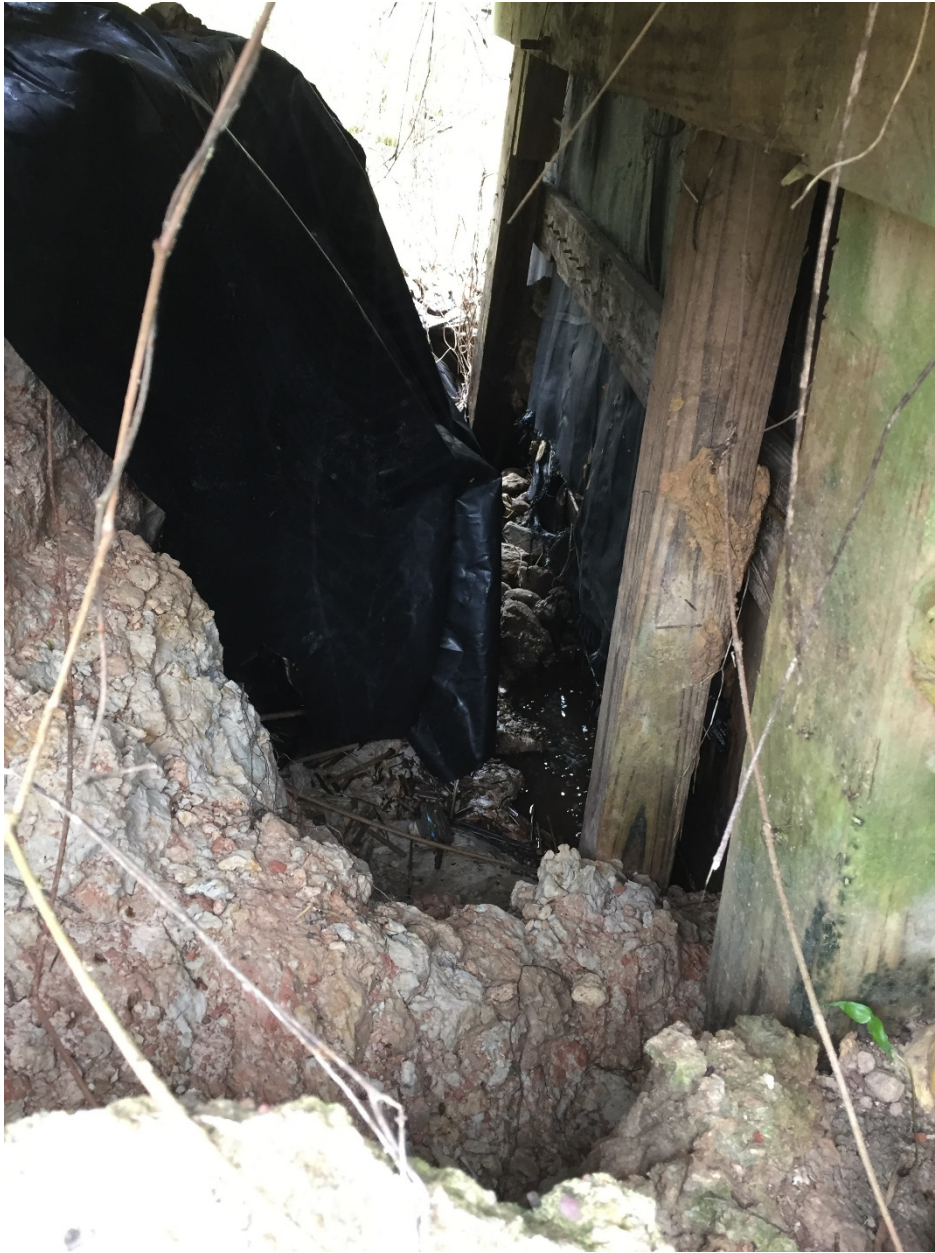
Figure 6. Levee erosion on the left side (looking downstream from the wetland to the pond) of the weir spill way
